**SELAH WASTEWATER TREATMENT PLANT
RECEIVING WATER SURVEY
OCTOBER 1988**

by
Joe Joy

Washington State Department of Ecology
Environmental Investigations and Laboratory Services
Surface Water Investigations Section
Olympia, Washington 98504

January 1990

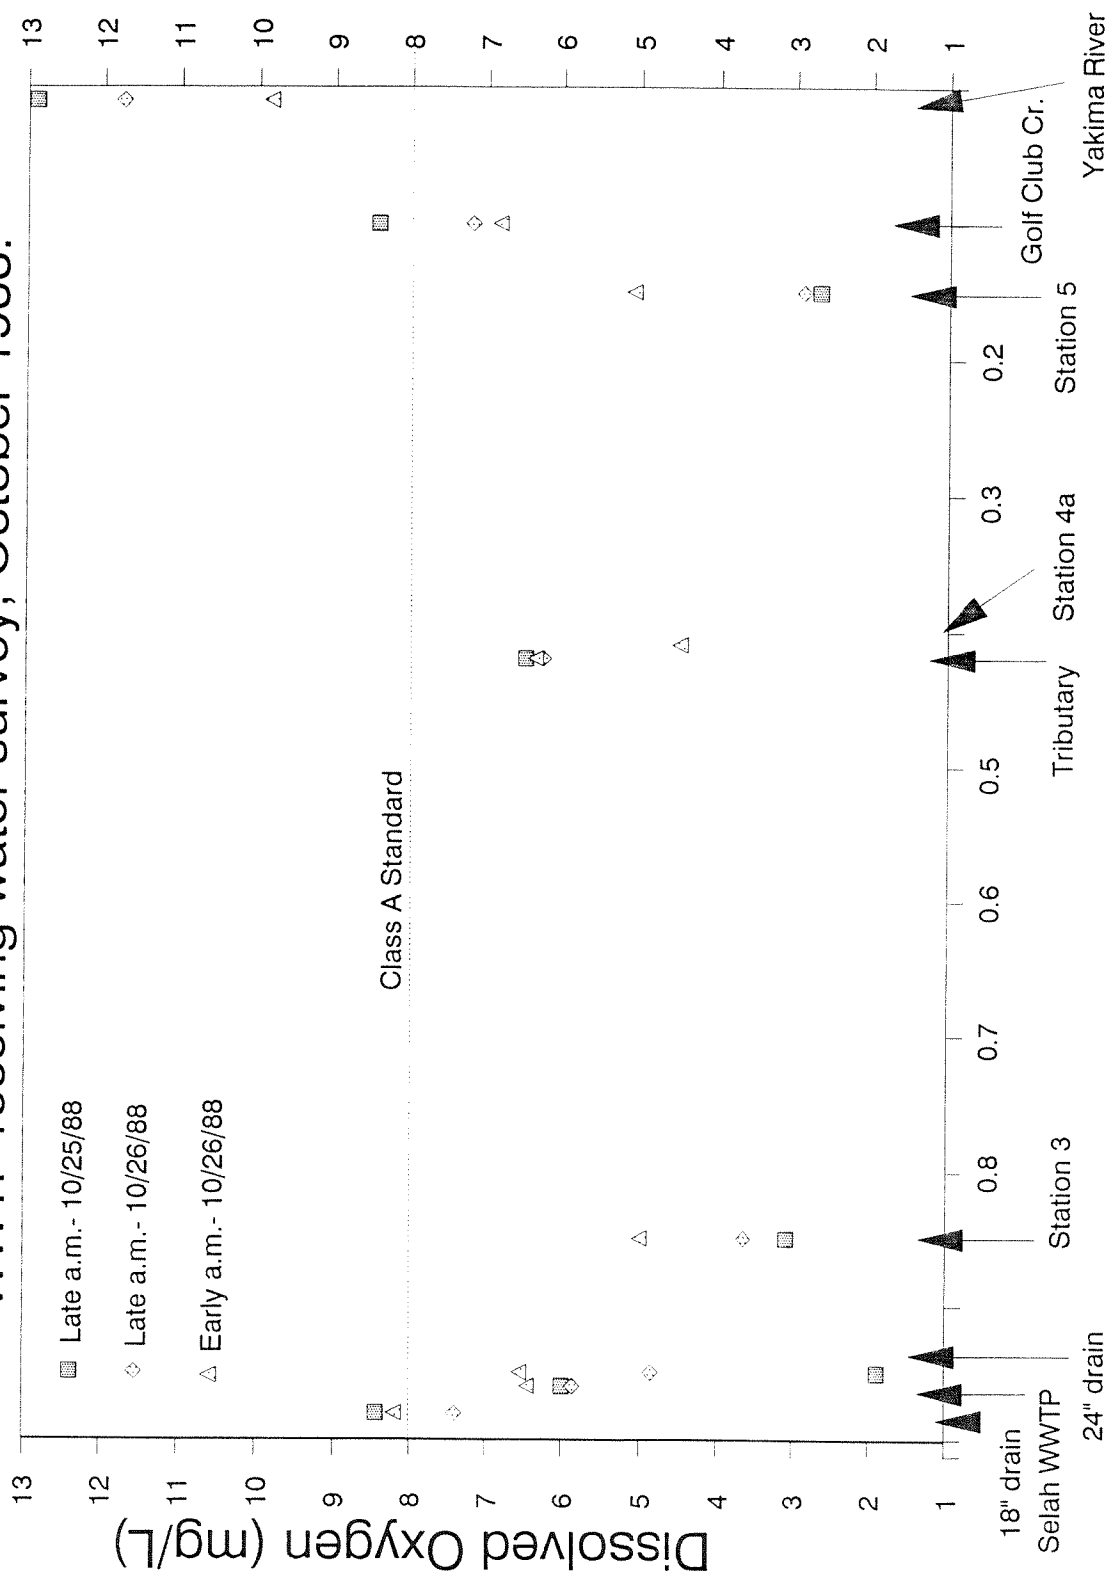
Figure 2. Dissolved oxygen concentrations at sites during Selah WWTP receiving water survey, October 1988.

In general, the "upstream" receiving water quality was very poor. It had a relatively low volume (less than 5 cfs), and high temperature (greater than 18 degrees C.). Fecal coliform levels (1100 to 15,000 organisms/100 mL) in samples taken from both sites greatly exceeded Class A criteria (Table 5). Although Station 1 dissolved oxygen (D.O.) concentrations were usually in compliance with the 8 mg/L Class A water quality standard, Station 2 concentrations were often less than 5 mg/L (Figure 2).

In contrast to the 24-inch drain, the WWTP effluent had BOD concentrations less than 3 mg/L (Table 5), with D.O. concentrations from 5.8 mg/L to 6.45 mg/L (Figure 2). Since the average initial dilution ratio of effluent in the ditch was 1.4:1, and 3.2:1 after Station 2, the low D.O. WWTP effluent would have had a local impact on the ditch under more favorable receiving water quality conditions. For example, at 3.2:1 dilution of background cooling water with D.O. at 8.0 mg/L, a loss of 0.5 mg/L could be expected after complete mixing.
